May 5, 2017 city water pressure drop

By Matt McBride, October 27, 2017

Introduction

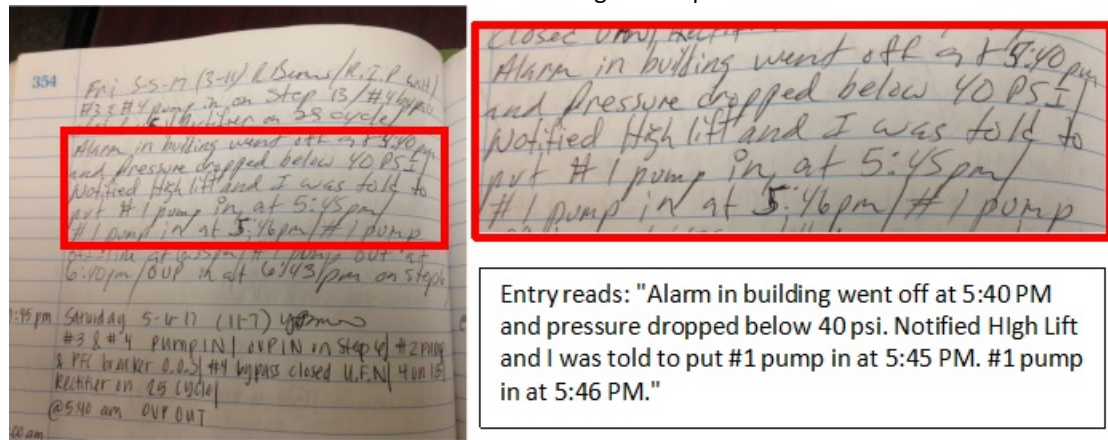
May 5, 2017 (3 PM - 11 PM shift) entry in Claiborne Station written logbook

Soon after the pressure drop, the High Lift operator spoke with the Claiborne Station operator. At the time of the loss of pumps A and B, pumps 3 and 4 at Claiborne Station were also running and pumping. This status is referred to as "in." Since two pumps alone are not enough to maintain adequate city water pressure, pump 1 at Claiborne Station was put "in" at 5:46 PM, according to the Claiborne Station clock. This is shown in the written logbook kept in Claiborne Station:

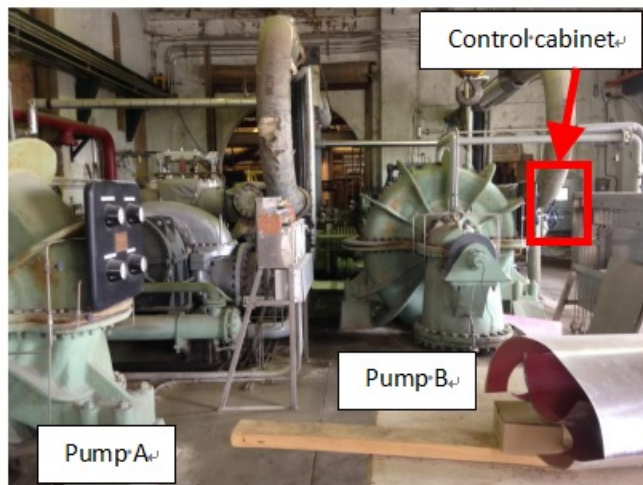
Pump A & B room at powerhouse

The cabinet housing the Woodward model 505 turbine controllers for pumps A & B and their common human-machine interface (HMI) is located in the A & B pump room:

According to interviews with senior powerhouse staff, the cabinet is powered off a 60 cycle alternating current feed with backup direct current power off the powerhouse batteries. Unbeknownst to staff, at some point prior to May 5, 2017 one of those power sources had failed. According to staff, the panel never alarmed on this condition because of a programming error. When the second power source to the cabinet failed, it took down everything controlled by the cabinet: both pumps A and B. This is what the 6:17 PM note in the Central Control logs was referring to:

Recommendation 2: Provide separate power supplies for each turbine controller for A and B pumps. Each should also be backed up independently, and each should have its own HMI to prevent errors. Also, alarms from each HMI should be sent out beyond the pump room. These changes could be incorporated into the boiler room upgrade project which will be kicking off soon.

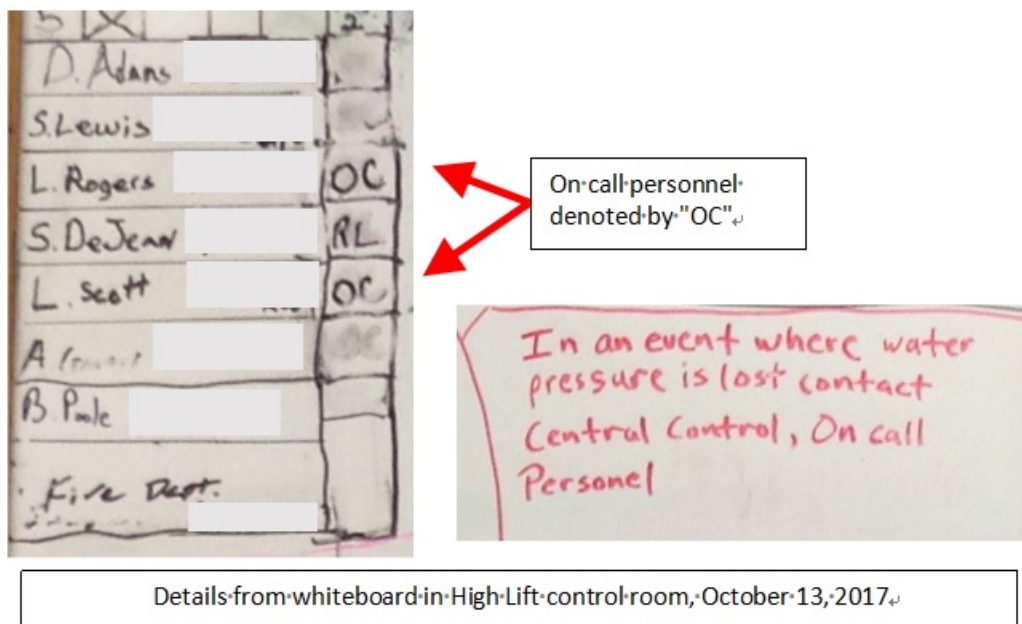
As to notification of personnel beyond High Lift during a low water pressure event, the system is a mix of low tech phone calls and some electronics. Since the High Lift operator's time is best spent on responding to such an event, notifications by the operator are kept to a minimum. The whiteboard in the High Lift control room includes information for the High Lift operator, indicating just On Call personnel and Central Control should be contacted:

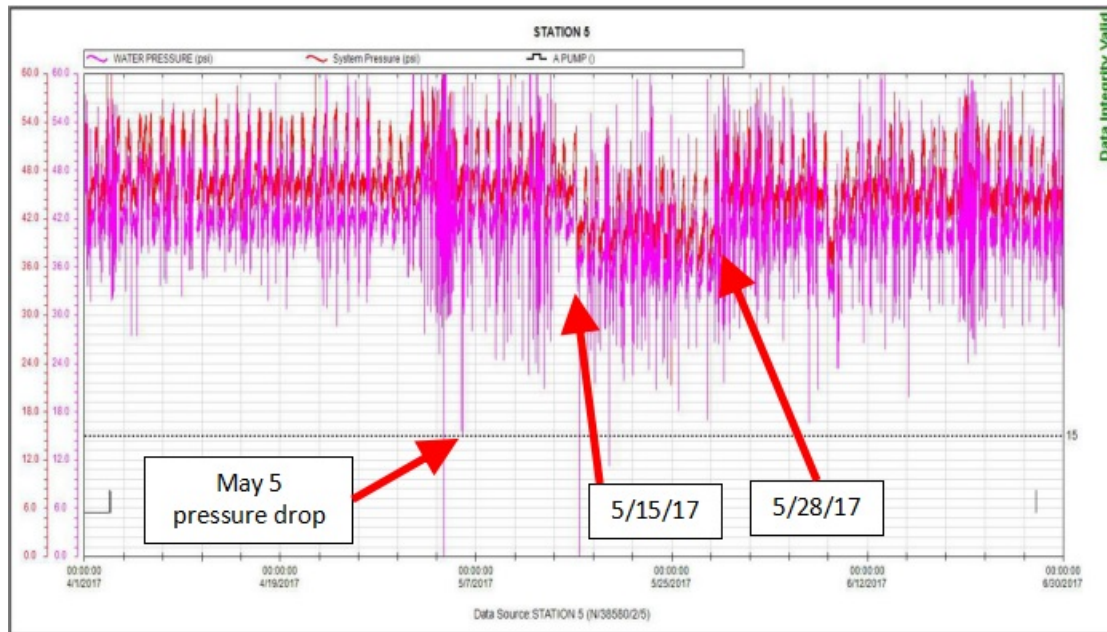
In May the system experienced two problems. Similar to DPS #1, the SCADA system recorded a great deal of volatility on May 3 and May 4. Also, DPS #5 SCADA system also appeared to suffer a days-long lowering of its water pressure data, with average pressures for both inlets dropping about 5 to 6 psi between May 15 and May 28. Both these problems have also been seen at other pump stations, indicating they are not localized to DPS #5.

DPS #5 water pressure (purple) and system pressure (red) from 4/1/17 to 6/30/17

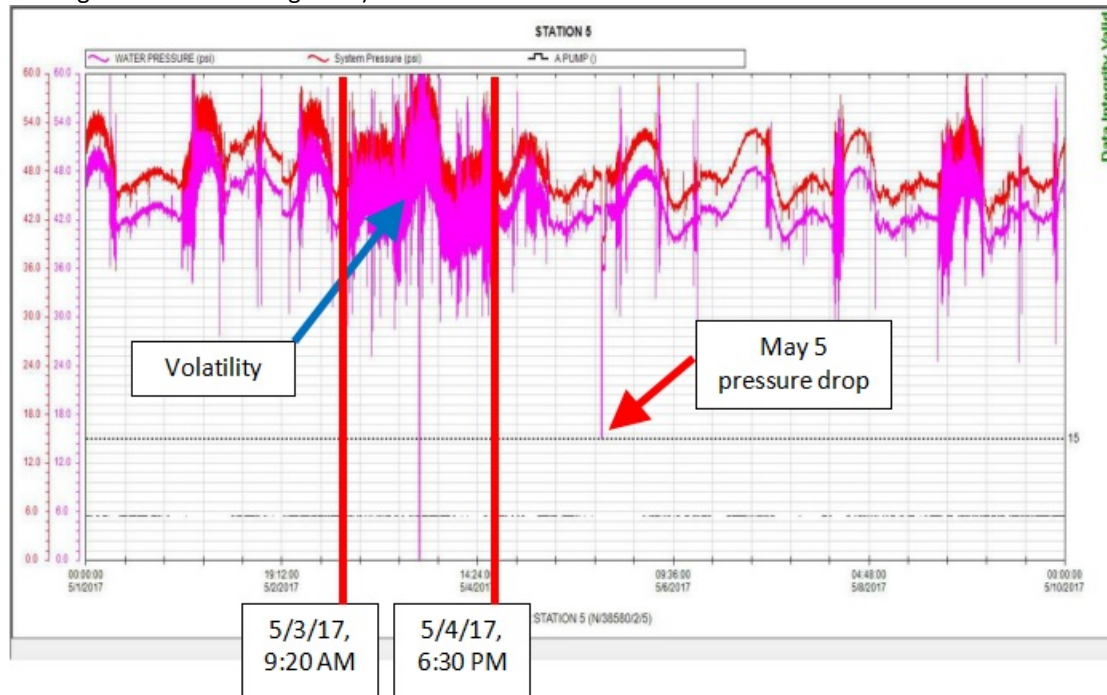
Zooming in to the beginning of May, one can see the volatility on May 3 and 4 clearly, and also how it had stopped by the time of the water pressure drop on May 5 (the daily up and down represents the normal rhythm of water pressure in the city, with a trough during the day's top demand and a peak overnight as demand sloughs off):

DPS #5 water pressure (purple) and system pressure (red) from 5/1/17 to 5/10/17

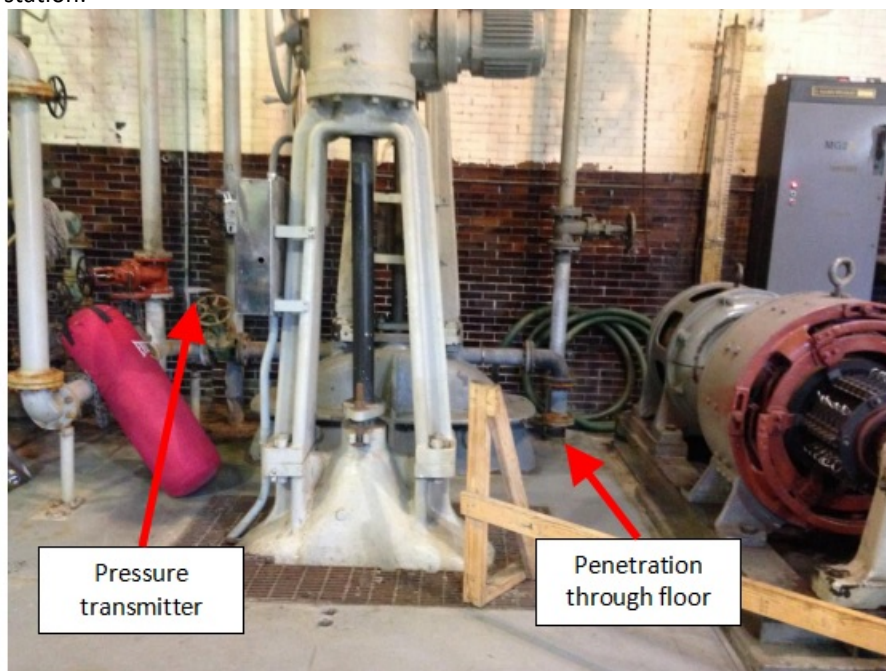
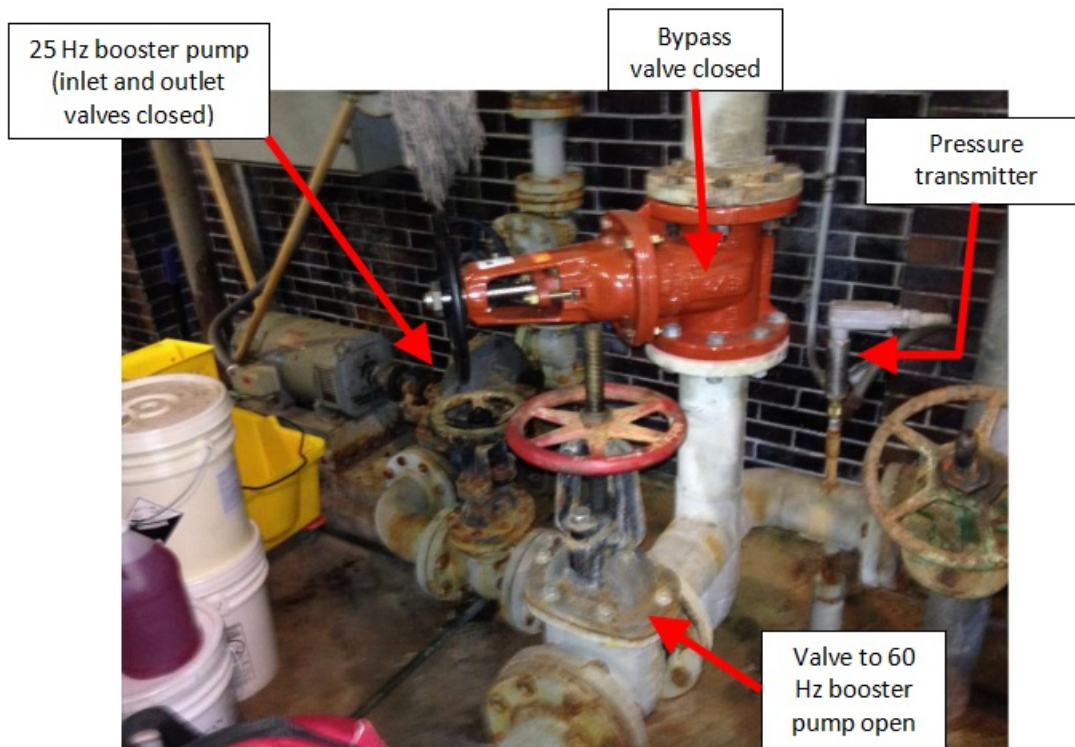
"Water pressure" city water inlet at DPS #7: penetration through floor (view looking north)

The transmitter is located upstream of three branches on the water system. Two of the branches - to the 25 Hz booster pump and to the booster pump bypass - have their valves closed and are thus isolated. The third branch leads to the 60 Hz booster pump:

Vicinity of "water pressure" transmitter at DPS #7

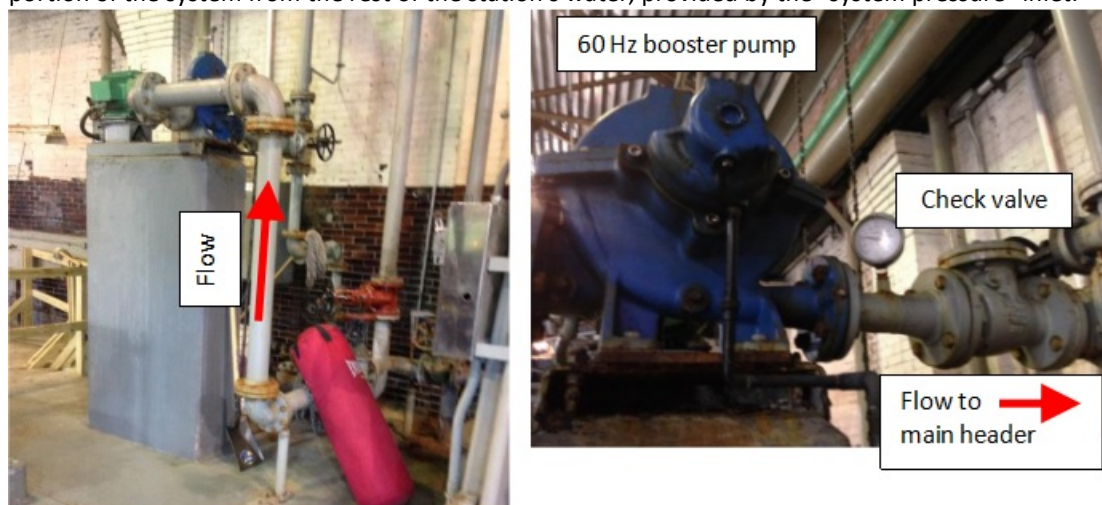
DPS 7 "water pressure" piping: 60 Hz booster pump

The likely reasons for this difference - that is, the much lower pressure on the "water pressure" side of the system - are the massive water leaks on the shaft seals of both constant duty pumps. These seals are fed from the "water pressure" line. The leaks are so huge that the constant duty pump pit has water to a depth of a few feet in it, and a sump pump is permanently pumping water out of the pit and into the suction basin. Video of the pit when inundated is available here:

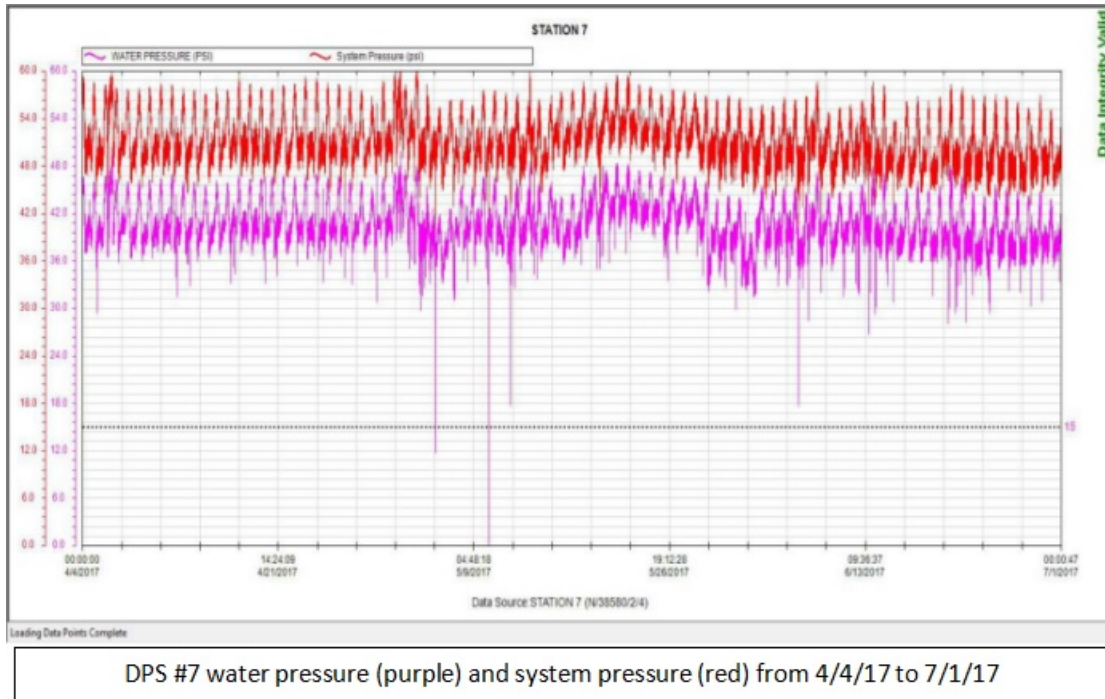
This isolation occurs because the "system pressure" at DPS #7 is always a great deal higher than the "water pressure," so the check valve only opens when the booster pump is activated. Otherwise, "water pressure" stays about 10 psi below "system pressure:"

However, until those repairs take place, the "water pressure" side of the station water system will have a pressure below the actual local city water pressure. It is possible it is as much as the current difference - about 10 psi.

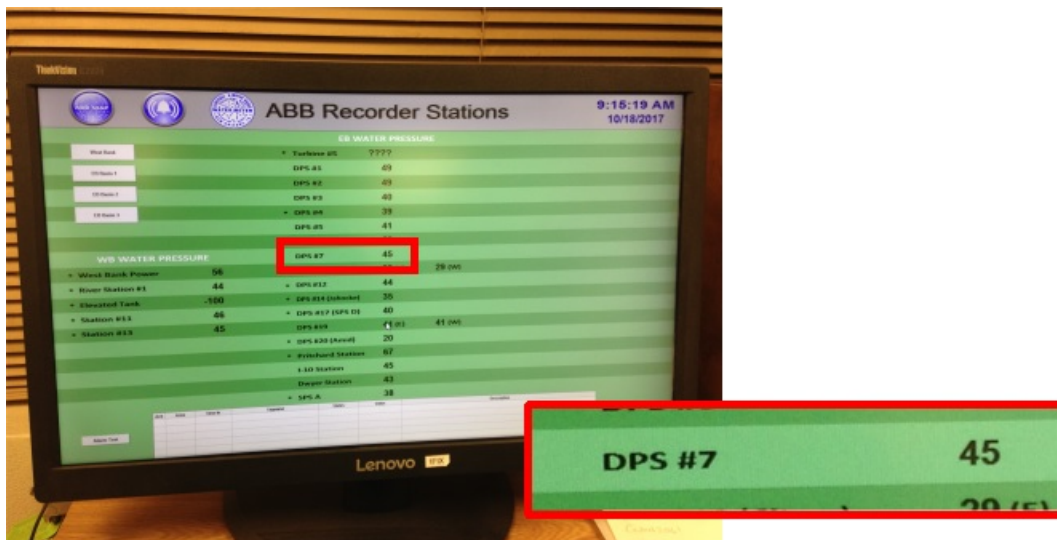
DPS #7 "system pressure" shown on Central Control SCADA display

Displays on the same network are showing two different pressure readings from the same station. Only one reading - the one shown at Central Control - is likely truly reflective of local city water pressure near DPS #7.

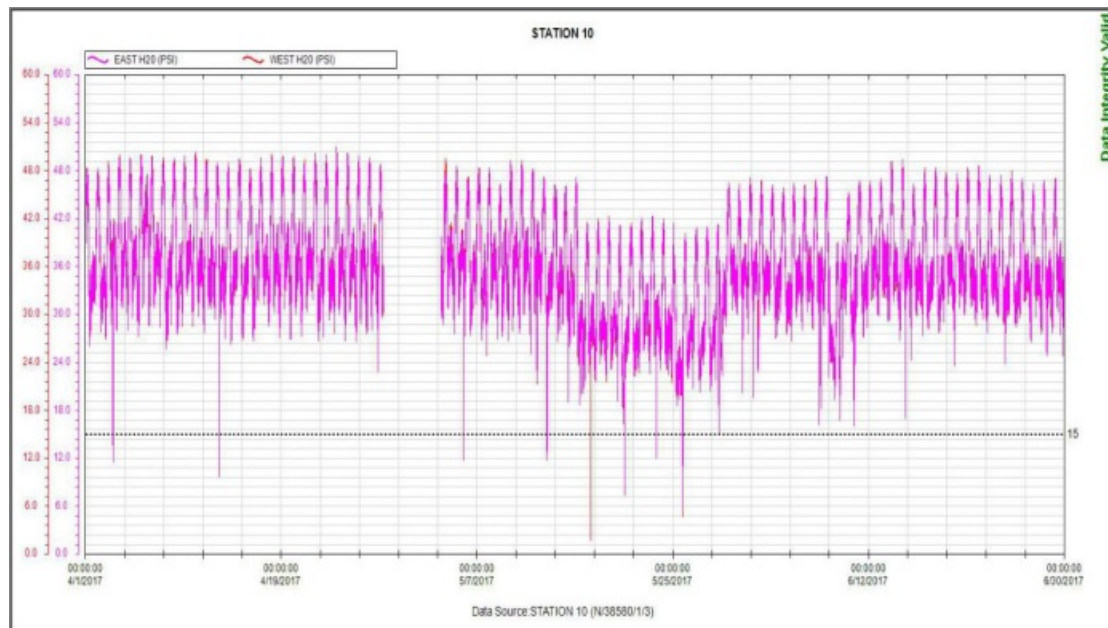
DPS #10 East H2O (purple) and West H2O (red) from 4/1/17 to 6/30/17

During this period, like at other stations, there appear to have been pressure problems. For example, as at DPS #1, SCADA data for water pressures was lost between April 28 and May 3. No explanation for this loss is known.

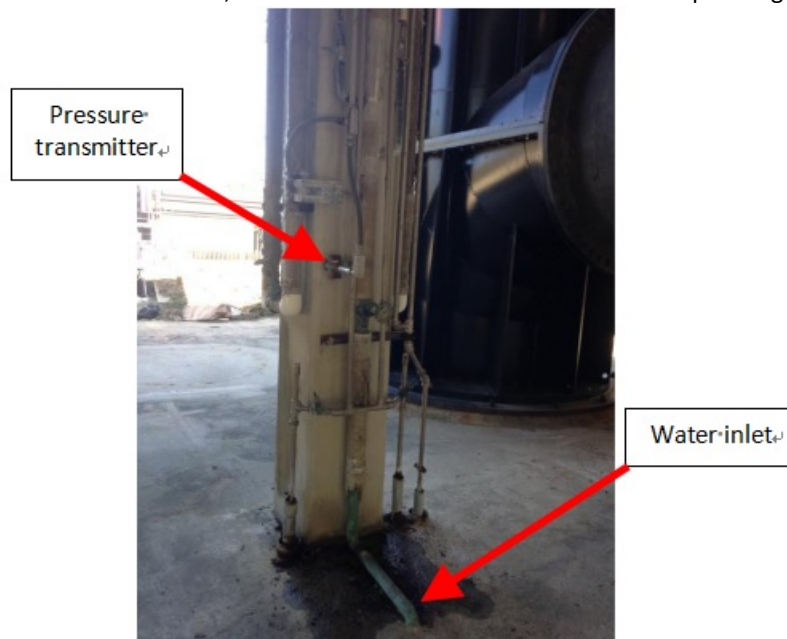
DPS #20 city water inlet, labeled "water pressure" in station SCADA system.

But the distinguishing characteristic of the pressure readings at DPS #20 is the diminished pressure read by the transmitter labeled "water pressure." This section of water piping directly feeds the water seals on the two drainage pumps. The "system pressure" leg feeds something else, probably the control room facilities. I can only surmise there is a substantial leak somewhere in the "water pressure" portion of the system, or the pressure in that section is being kept artificially low. When the station was visited in late October, pressure on the "water pressure" portion of the system was running even lower than in the spring: in the low 20's. The pressure had been that low since early October, when it dropped at the same time as "system pressure:"

While it is conceivable that the city water pressure from the "water pressure" leg into the station is actually in the low 20's, it seems unlikely. 22 psi is hardly enough pressure to do anything, and one has to wonder if it is truly adequate for the station's needs, especially the pump that was recently repaired under a Board emergency declaration.

Therefore, given the large historic gap between "system pressure" and "water pressure" at DPS #20, it does not seem warranted to consider "water pressure" there as representative of local city water pressure.

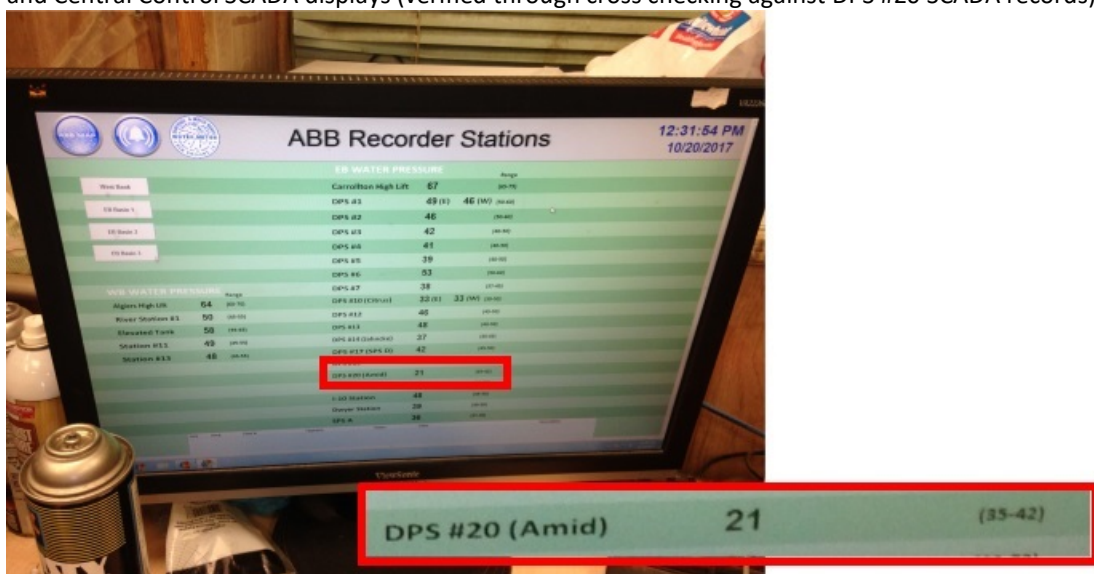
DPS #20 "water pressure" shown on High Lift SCADA display.

Once again, as with DPS #7, it appears that a non-representative water pressure has been chosen to portray local city water pressure to senior Board staff. There is, of course, a chance that the "water pressure" inlet at DPS#20 truly does run so low as to almost routinely approach 15 psi. If that is the case, there is a serious problem with the local water pressure in the area. However, the much higher pressure from "system pressure" makes that chance quite small.

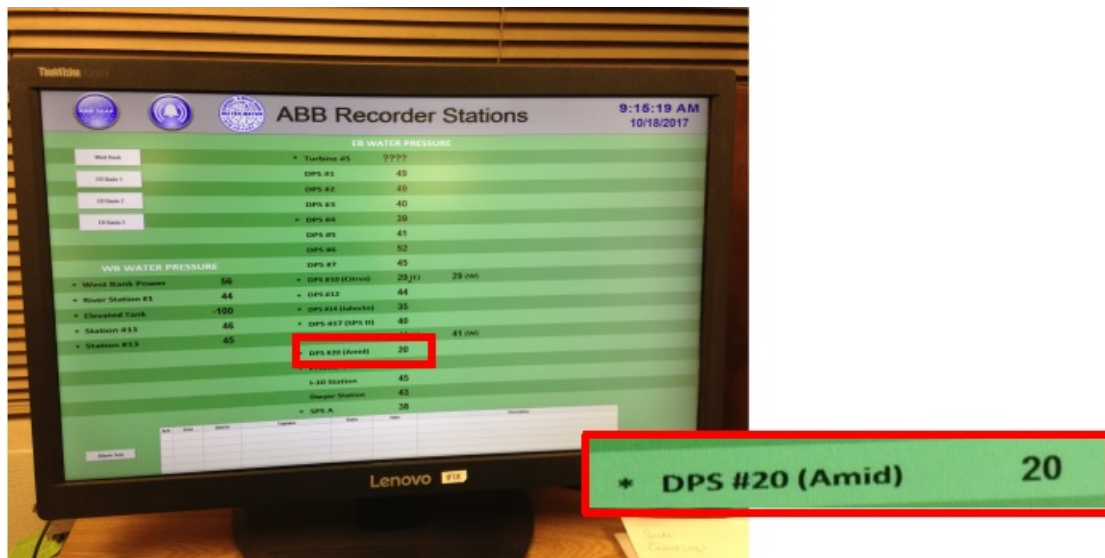
DPS #20 "water pressure" shown on Central Control SCADA display.
